Entrance Channel 2011 Bathymetry & Athena Washprobes

Entrance Channel Composite Geotechnical Overlay

PLATE 5: CHARLESTON HARBOR ENTRANCE CHANNEL COMPOSITE OVERLAY OF WASHPROBE, HISTORICAL BORINGS, GREAT LAKES CLAIM & NOAA DIVER MAPPING

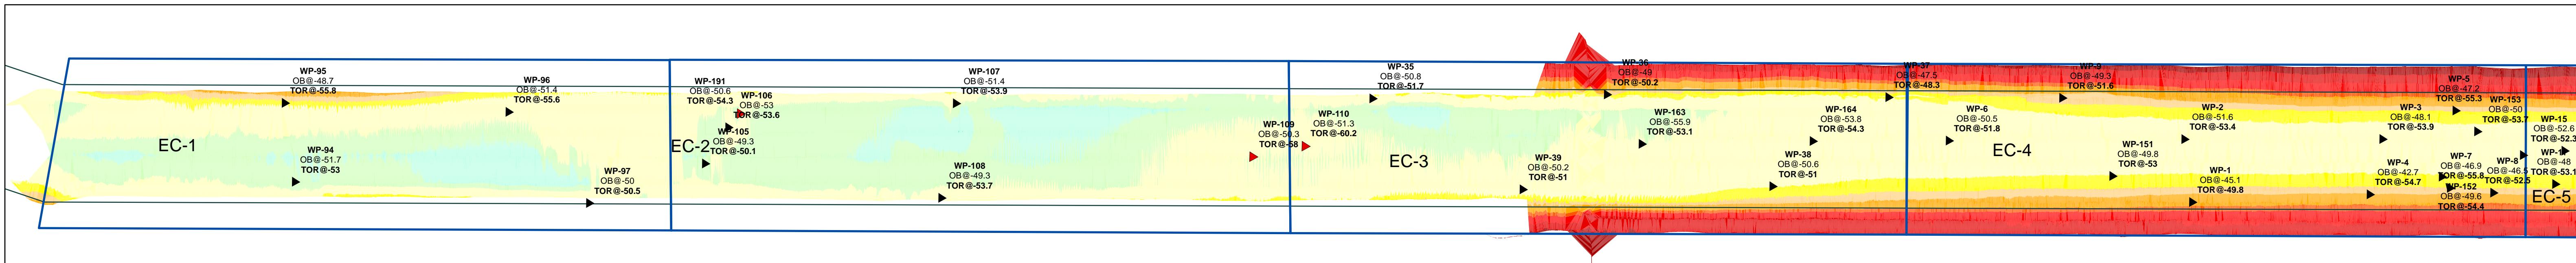
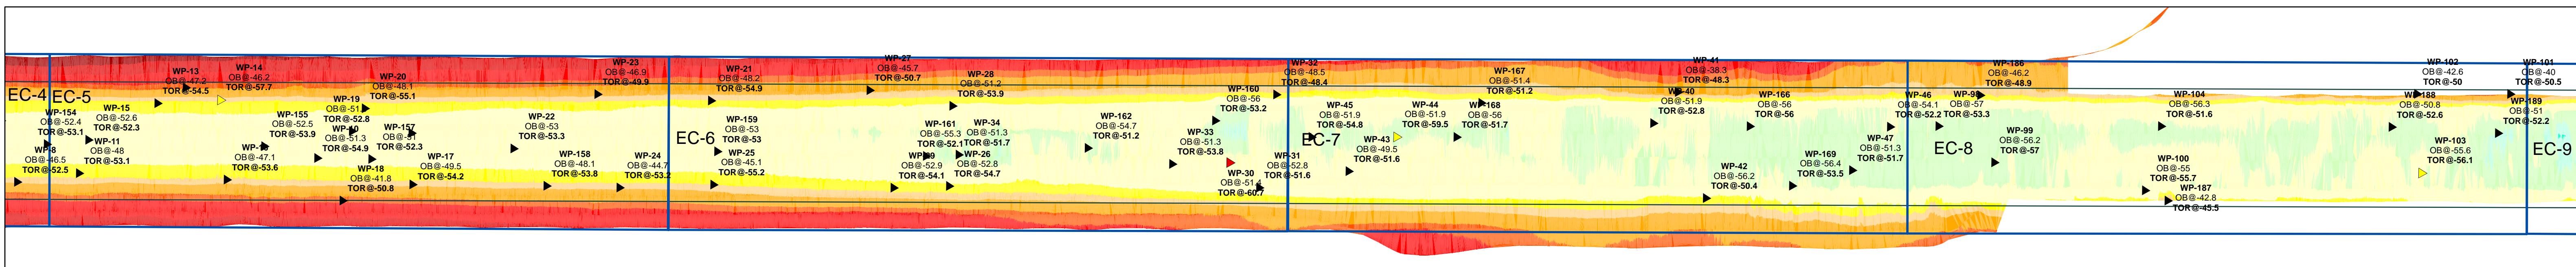
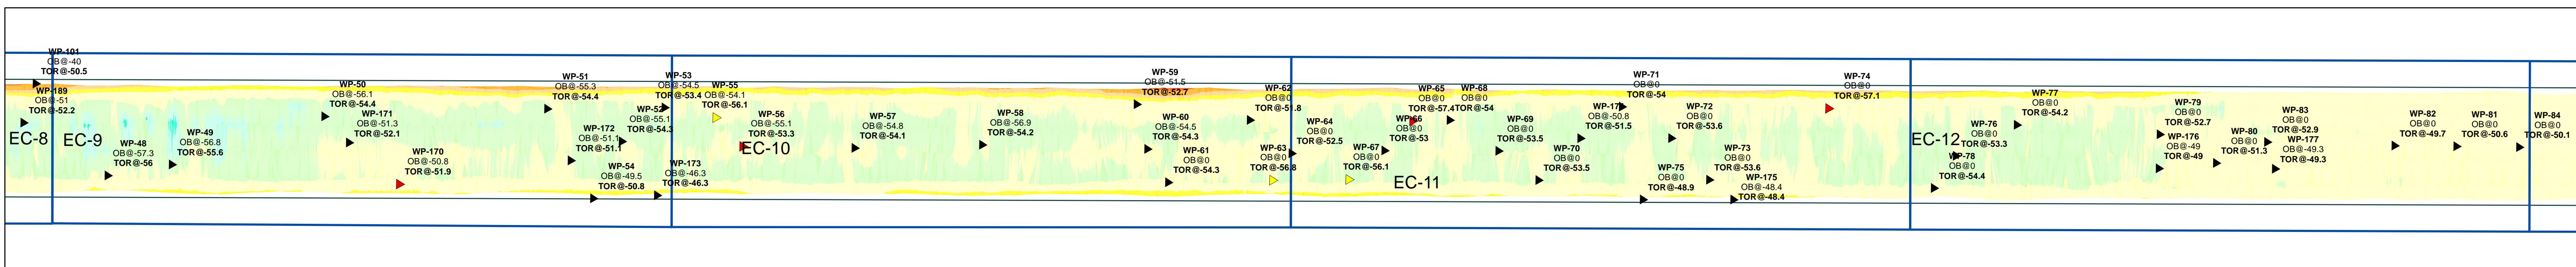
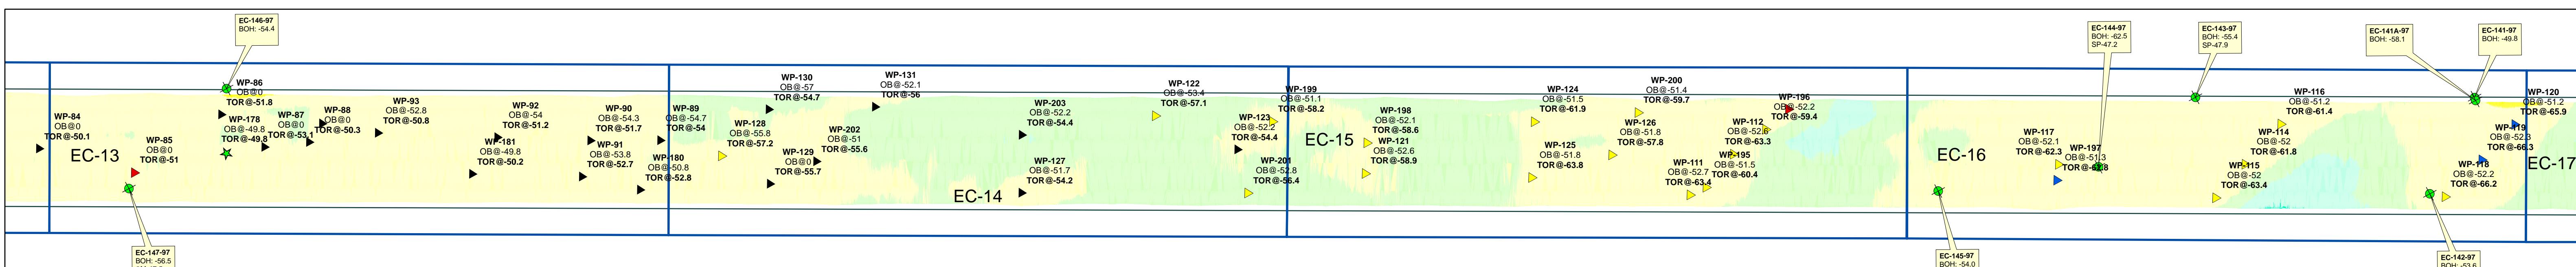
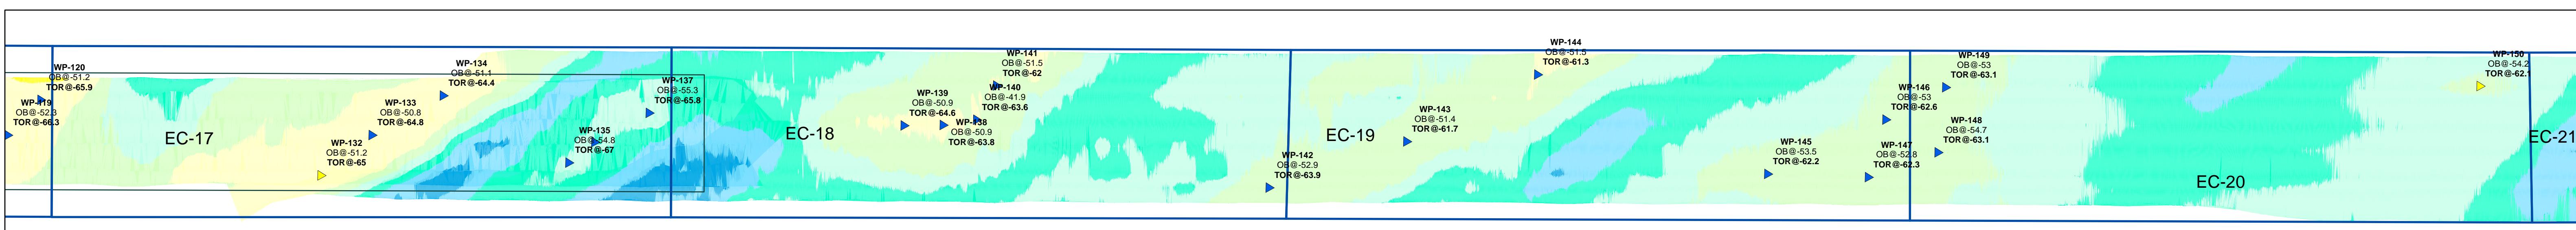
Entrance Channel Sub-Sections 2011 Condition Survey	
Athena 2013 Washprobes	Bathymetry (MLLW)
Description	
Refusal within Dredge Prism	40 - 44
Below -56 MLLW	44 - 46
No Refusal Encountered	46 - 48
Poss Rock Encountered	48 - 52
Video	52 - 54</

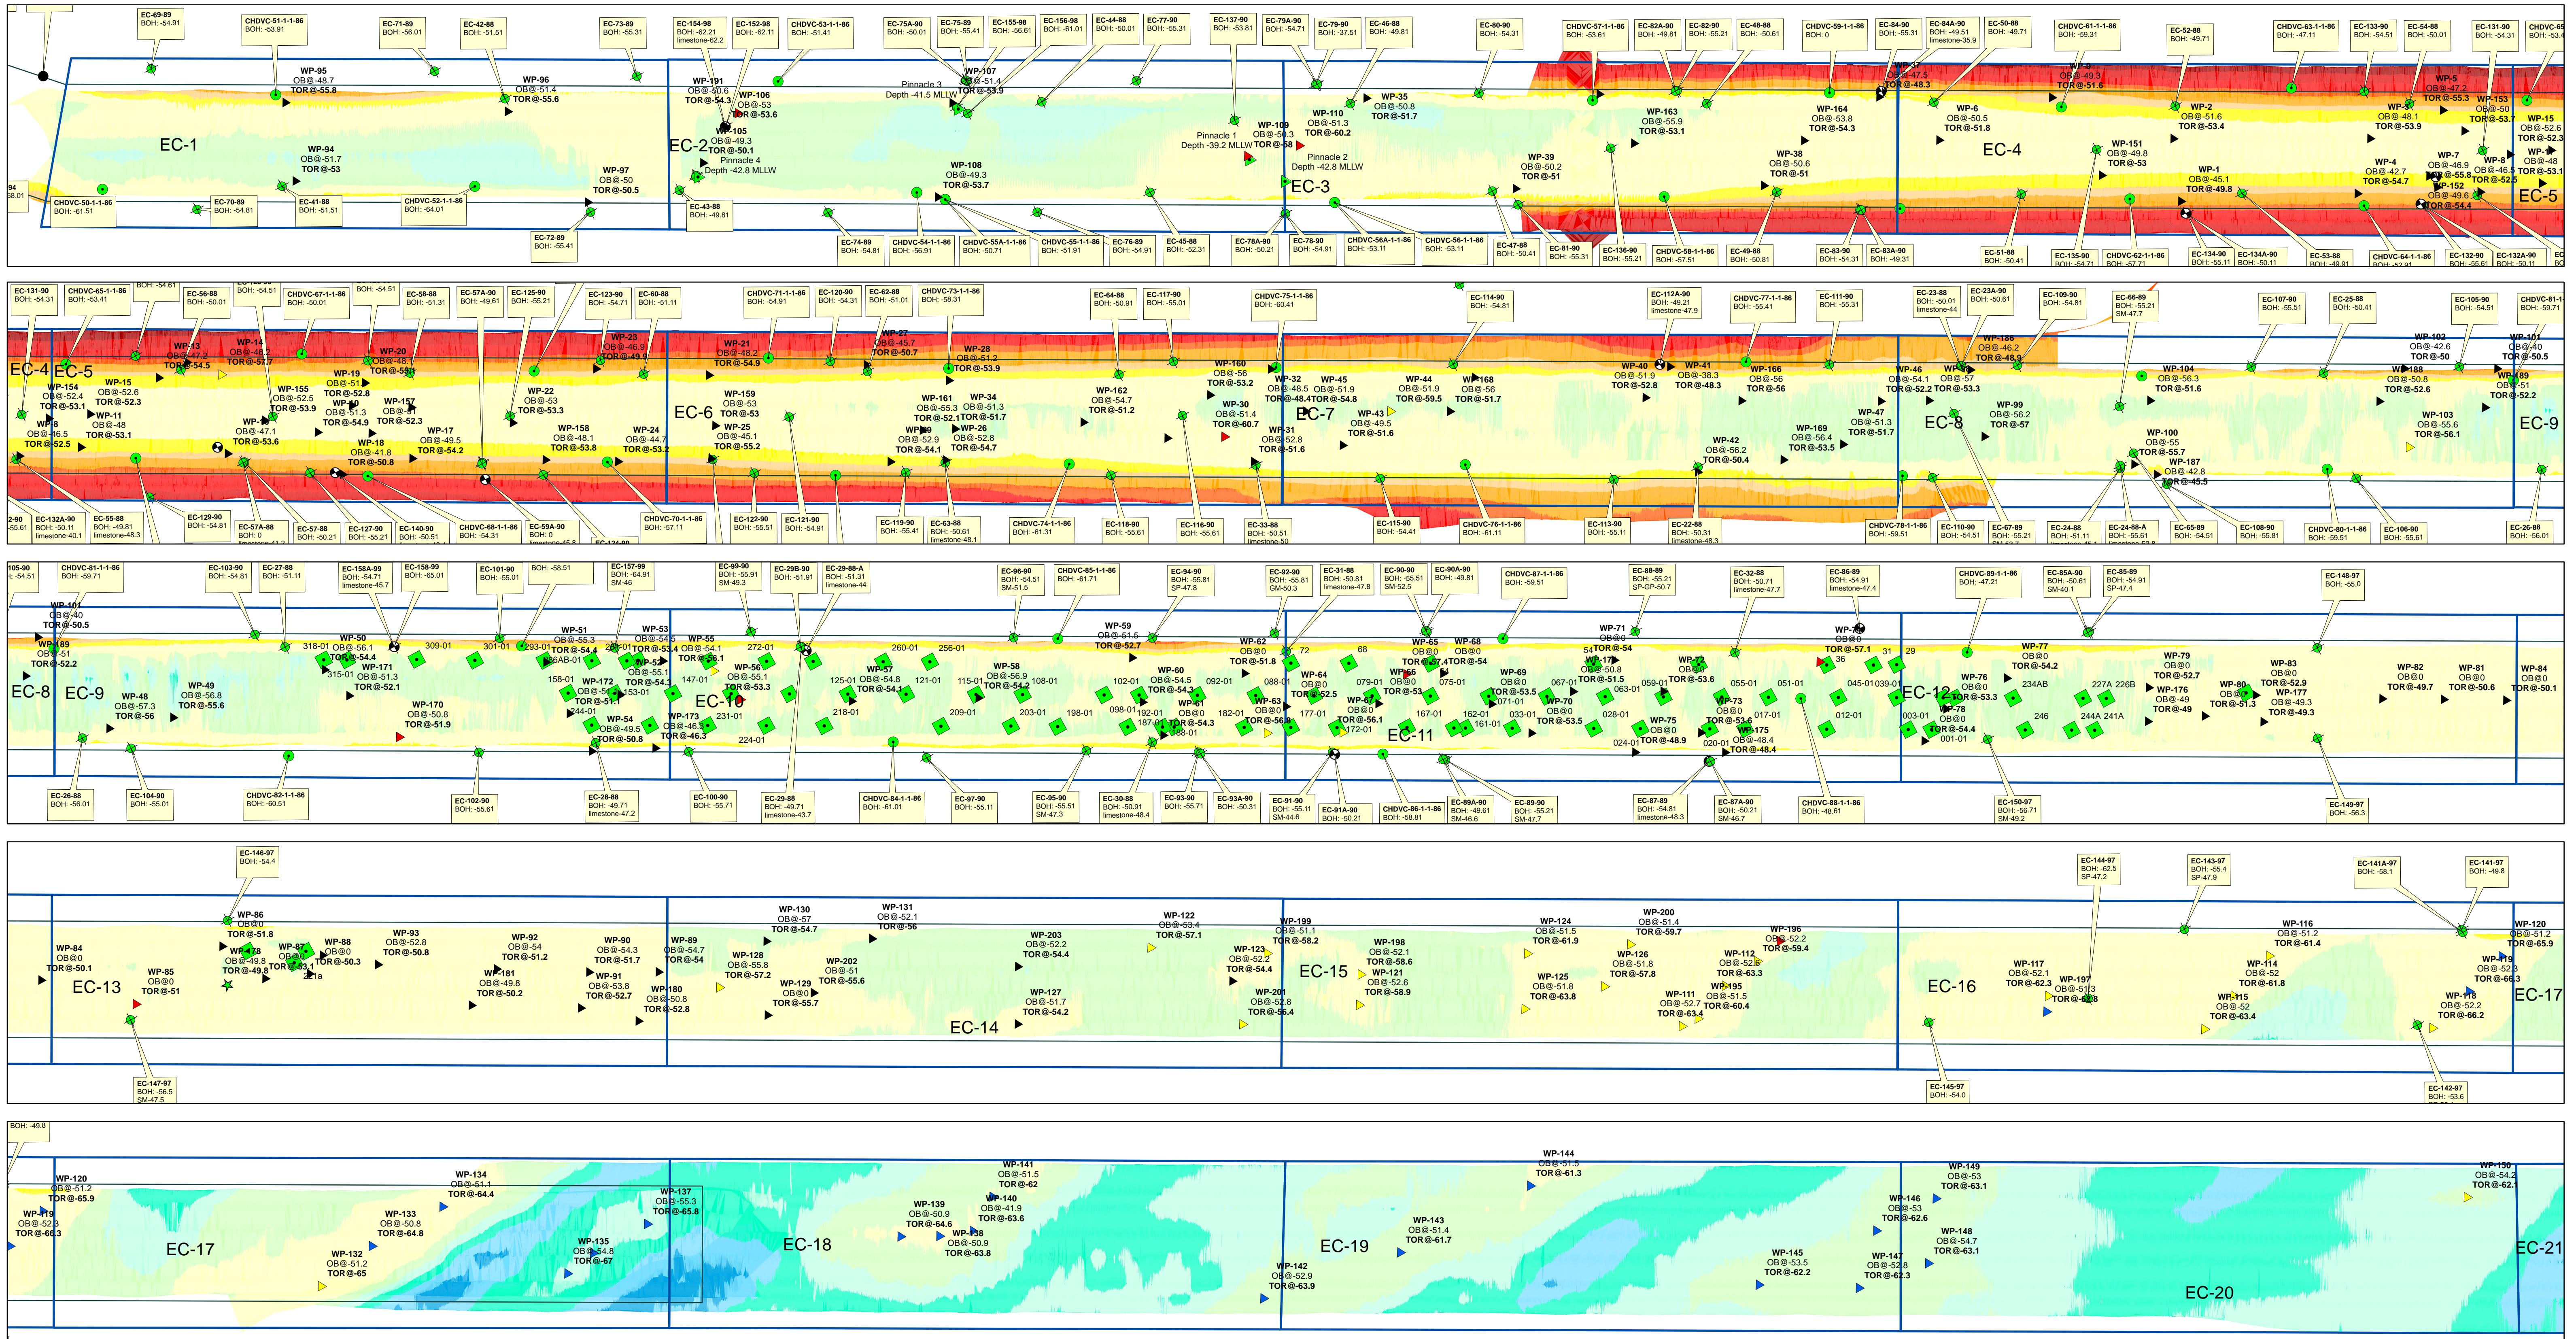
Athena 2013 Washprobes

Refusal within Dredge Prism

Below -56 MLLW

No Refusal Encountered

Poss Rock Encountered

Borings 1986-1999

NOAA Rock Pinnacles

Diver Verified 1998

2011 Condition Survey

Bathymetry (MLLW)
